DTNSRDC-80/127

4. TITLE (and Subtitle) MECHANISM OF SULFIDE-ACCELERATED CORROSION OF COPPER-NICKEL (90-10) ALLOY IN SEAWATER		5. TYPE OF REPORT & PERIOD COVERED Final

7. AUTHOR(s) Malcolm E. Schrader		6. PERFORMING ORG. REPORT NUMBER
9. PERFORMING ORGANIZATION NAME AND ADDRESS David W. Taylor Naval Ship R&D Center Bethesda, Maryland 20084		8. CONTRACT OR GRANT NUMBER(s) 1573

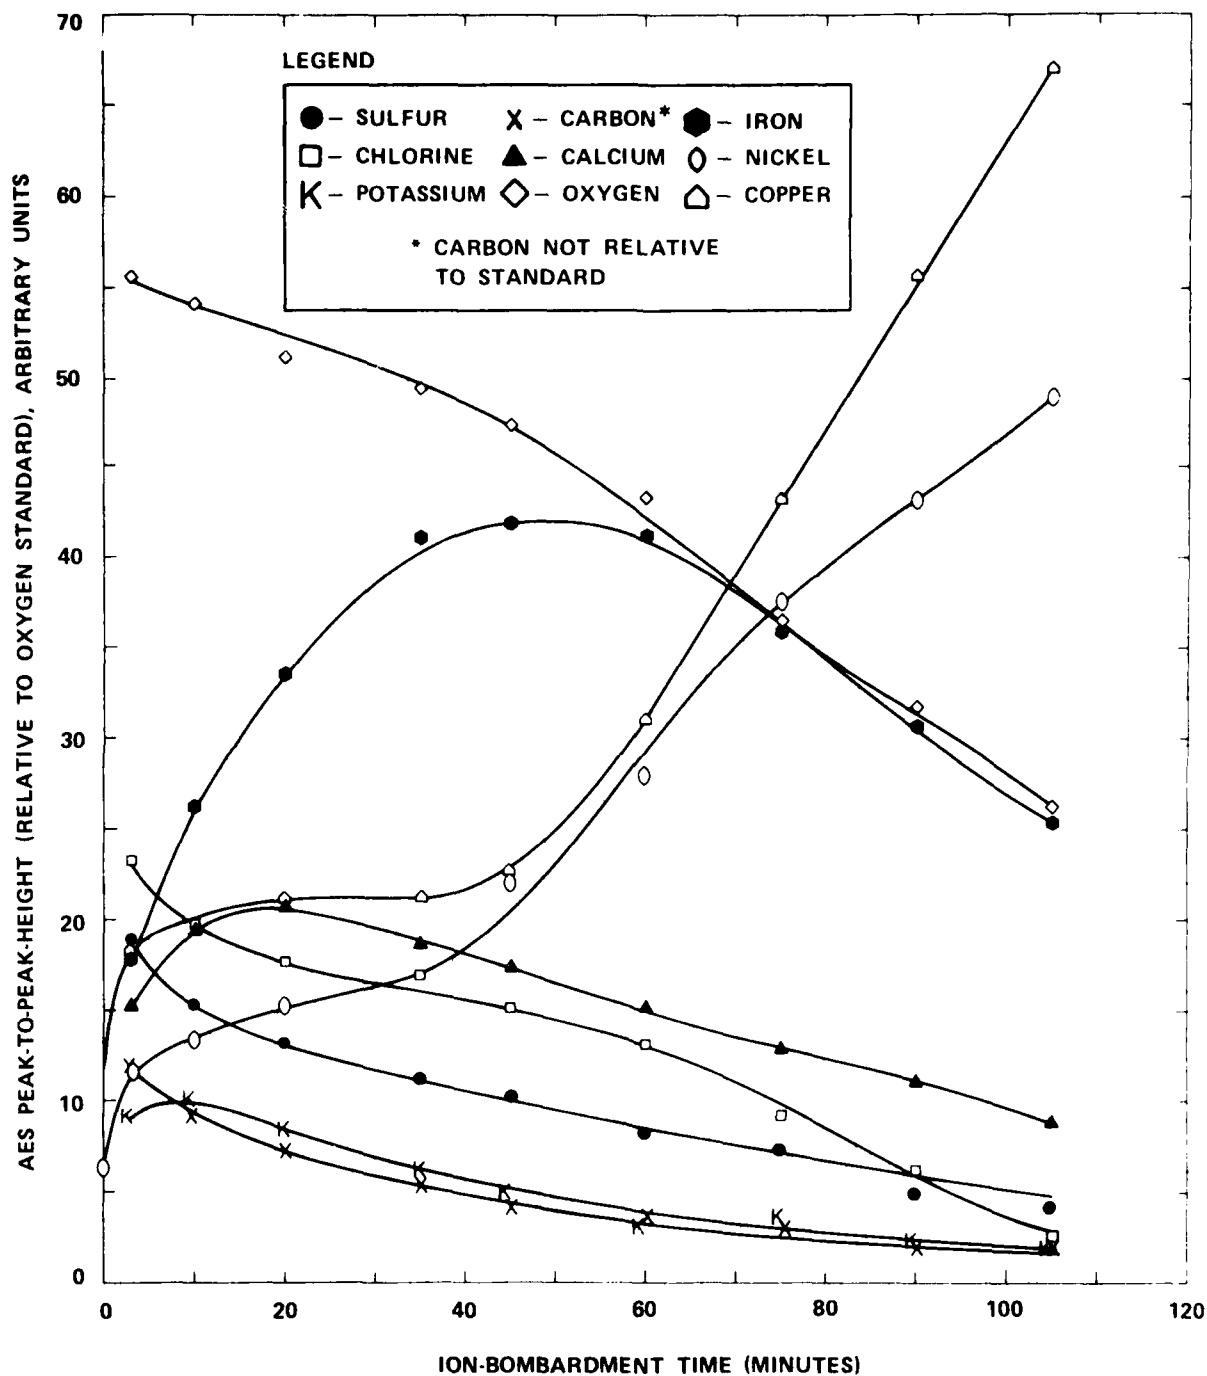
Figure 1 - Depth Profile of Elements in Surface Region as Determined by Auger Electron Spectroscopic Analysis During Ion-Bombardment: Copper-Nickel (Iron) Alloy Exposed to Fresh Seawater for 30 Days

Auger electron spectroscopy with ion-bombardment profiling (Figure 1) of the 30-day exposed FSW surface yielded a number of noteworthy features. The outer layer, after 3 min ion bombardment, contained carbon, oxygen, chlorine, sulfur, copper, nickel, iron, calcium, and potassium. Additional carbon, from the over-layer of organic molecules deposited on air-exposed surfaces, was probably removed during the first 3 min. Potassium, sulfur, and the remaining carbon decreased steadily from their initial values during the course of ion bombardment. Calcium and chlorine, with minor fluctuations, also followed this behavior. Copper remained reasonably steady during the first 45 min then started to increase rapidly. Nickel increased slowly at first then started to increase rapidly at about 40 min. Iron increased rapidly for 45 min, then decreased fairly rapidly. Oxygen decreased slowly for 45 min, then decreased fairly rapidly, at the same rate as iron. The behavior of iron was striking, in two respects. First, as mentioned, it was the only constituent (of the corrosion film) to go through a substantial maximum well into the corrosion film. Second, and even more striking, is the fact that although iron is only 1 1/2 percent of the bulk alloy composition, it is present in larger amounts than either copper or nickel in the corrosion film.

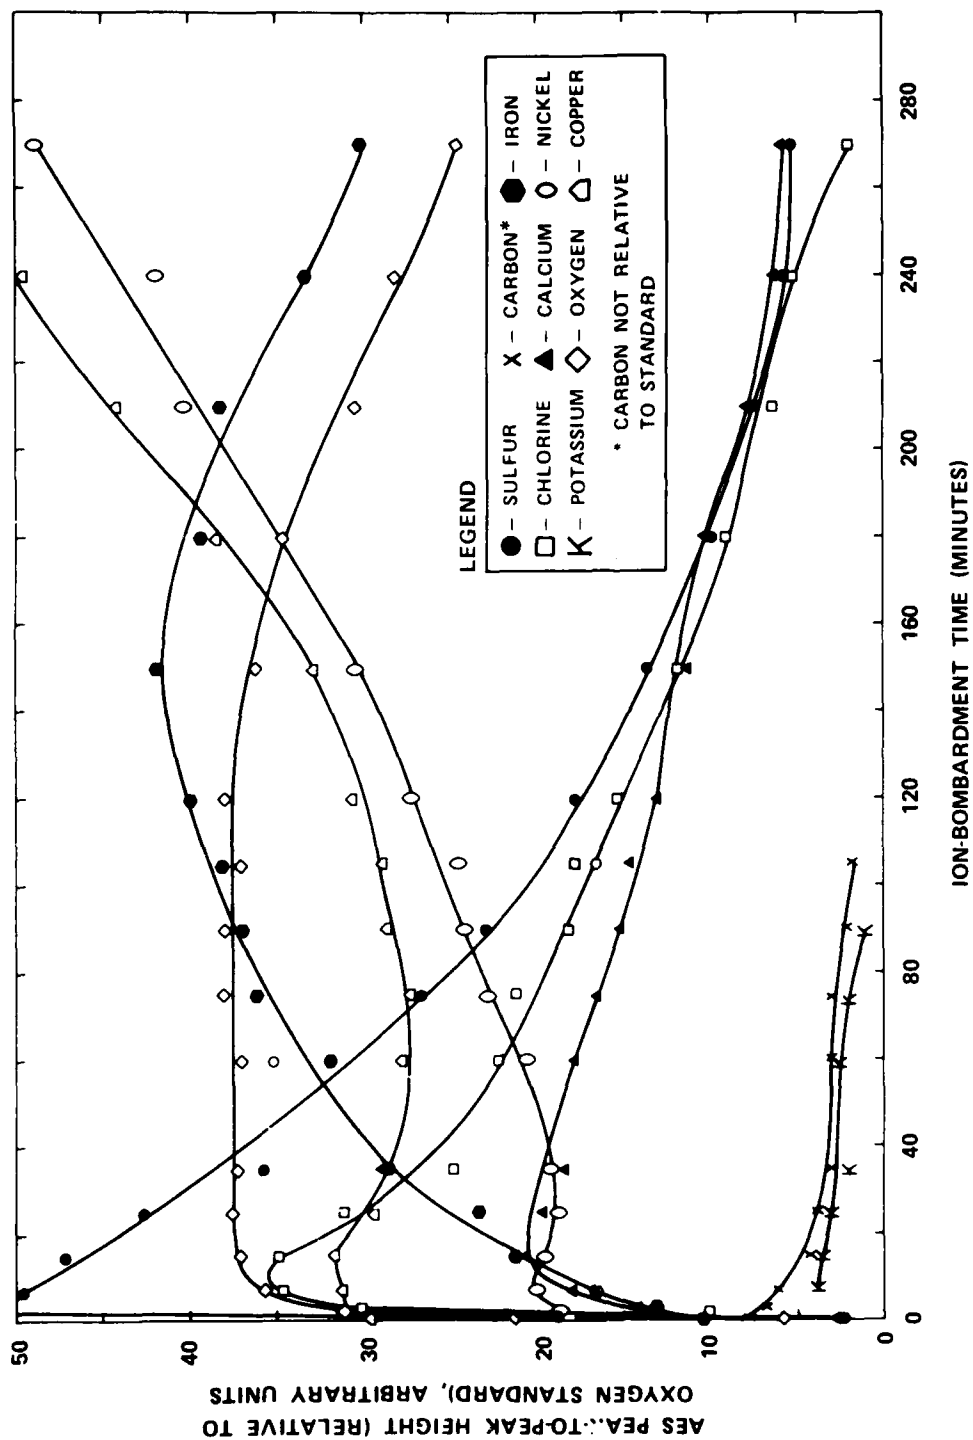
Figure 2 - Depth Profile of Elements in Surface Region as Determined by Auger Electron Spectroscopic Analysis During Ion-Bombardment:
Copper-Nickel (Iron) Alloy Exposed to Sulfide-Containing Seawater for 30 Days

The AES analysis (Figure 2) of the 30-day exposed sulfide-containing seawater (SSW) yielded many similarities, but also some interesting differences, to the FSW surface. The entire curve was expanded along the time axis as compared to the FSW sample. This may be due either to a change in the physical nature of the film, or merely to a variation in the ion-bombardment conditions. For example, if the

incident electron beam for Auger analysis is focused near the top, rather than the bottom, of the ion-bombardment crater, the entire profiling procedure would appear to have slowed down. Except for the time factor, the iron curve is very similar to the previous one. The oxygen curve is also similar, especially on the right side of the iron maximum. Potassium, calcium, and carbon are roughly similar. Sulfur and chlorine, however, show interesting differences. In FSW, sulfur is present in moderate amounts at the start of profiling, and decreases routinely thereafter. In the SSW, sulfur goes through a very large and sharp maximum during the first few minutes of ion-bombardment, thereafter decreasing routinely from that value. Chlorine behaves similarly to sulfur during the first few minutes of profiling, except that the maximum is not as high or as sharp.

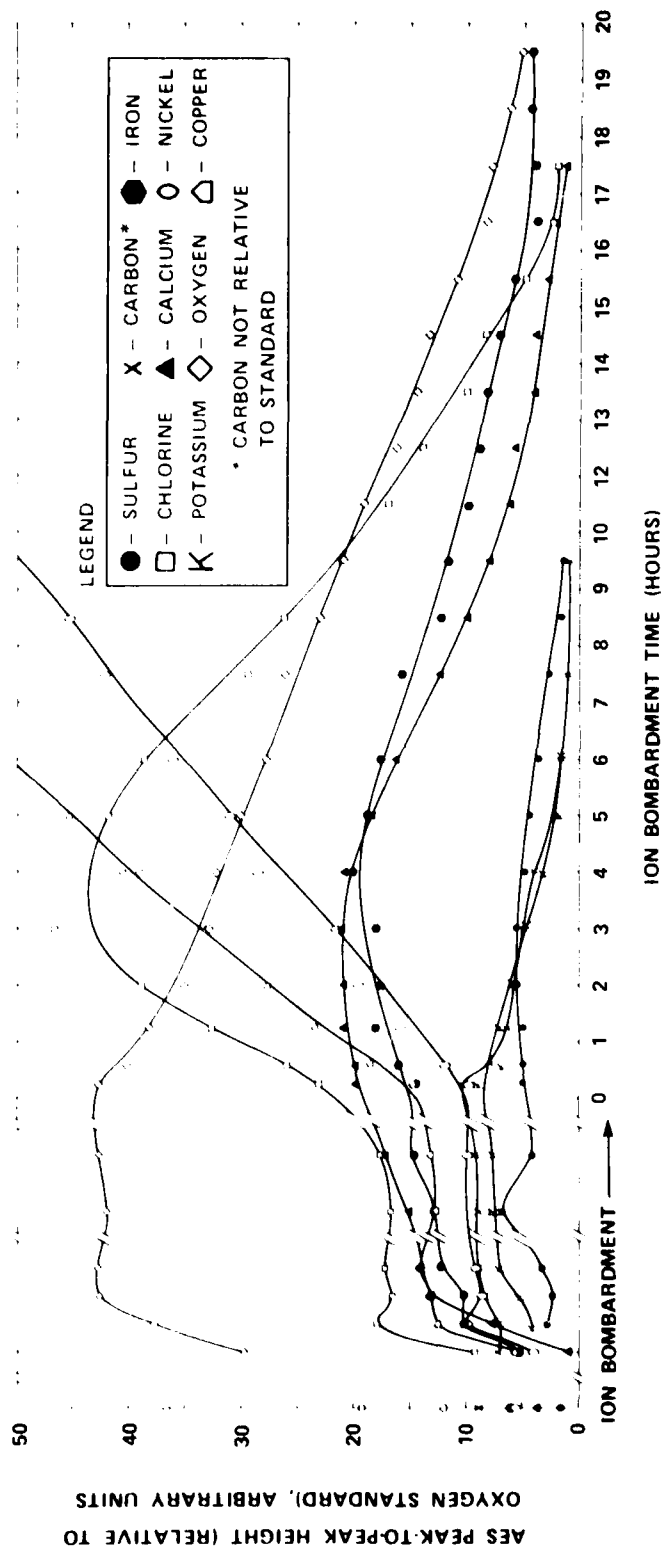
Figure 3 - Depth Profile of Elements in Surface Region as Determined by Auger Electron Spectroscopic Analysis During Ion-Bombardment: Copper-Nickel (Iron) Alloy Exposed to Fresh Seawater for 60 Days

The AES analysis of the 60-day FSW sample was rather difficult to perform. The grayish-blue patches were insulating films and yielded only charging and discharging signals. The dark patches were also somewhat insulating, but yielded Auger spectra during the course of ion-bombardment. On these dark patches (Figure 3) iron was present in an amount roughly equal to copper or nickel at the beginning, gradually decreasing as Cu and Ni increased and as the ion-bombardment exposed the substrate. There was very little sulfur in the film. Chlorine, however, was present in significant amounts and went through a maximum during the profiling.

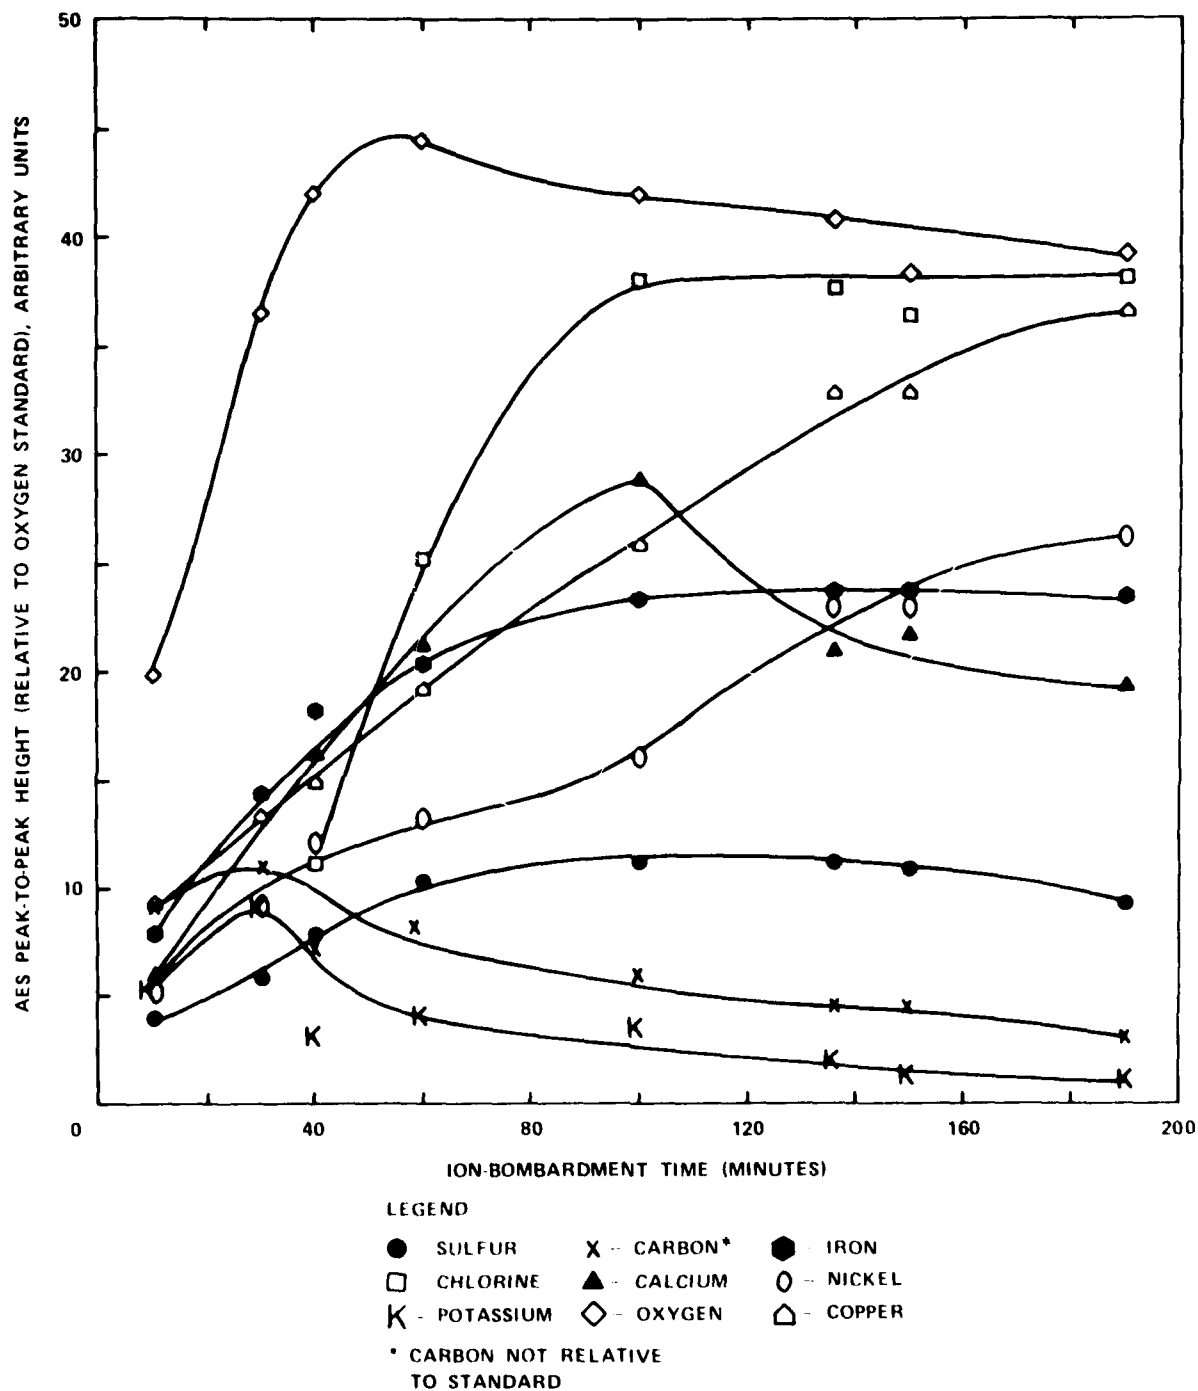
Figure 4 - Depth Profile of Elements in Corrosion-Film on Surface as Determined by Auger Electron Spectroscopic Analysis During Ion Bombardment: Copper-Nickel (Iron) Alloy Exposed to Sulfide-Containing Seawater for 60 Days

The AES on the 60-day SSW samples was performed both on areas covered with corrosion film (Figure 4) and on bare areas (Figure 5). On the corrosion film, potassium and carbon were present in small amounts, while copper and nickel increased routinely with ion-bombardment. Iron increased with ion-bombardment and appeared to be going through a broad maximum. Sulfur went through a broad maximum, qualitatively paralleling that of iron. Chlorine increased rather sharply then levelled off and declined slowly, while calcium went through a maximum. The maxima or levelling off points of iron, sulfur, chlorine, and sometimes calcium, all occurred in approximately the same region of the time axis. Oxygen went through a relatively early maximum. Chlorine went through a sharper and higher maximum than sulfur and peaked somewhat later.

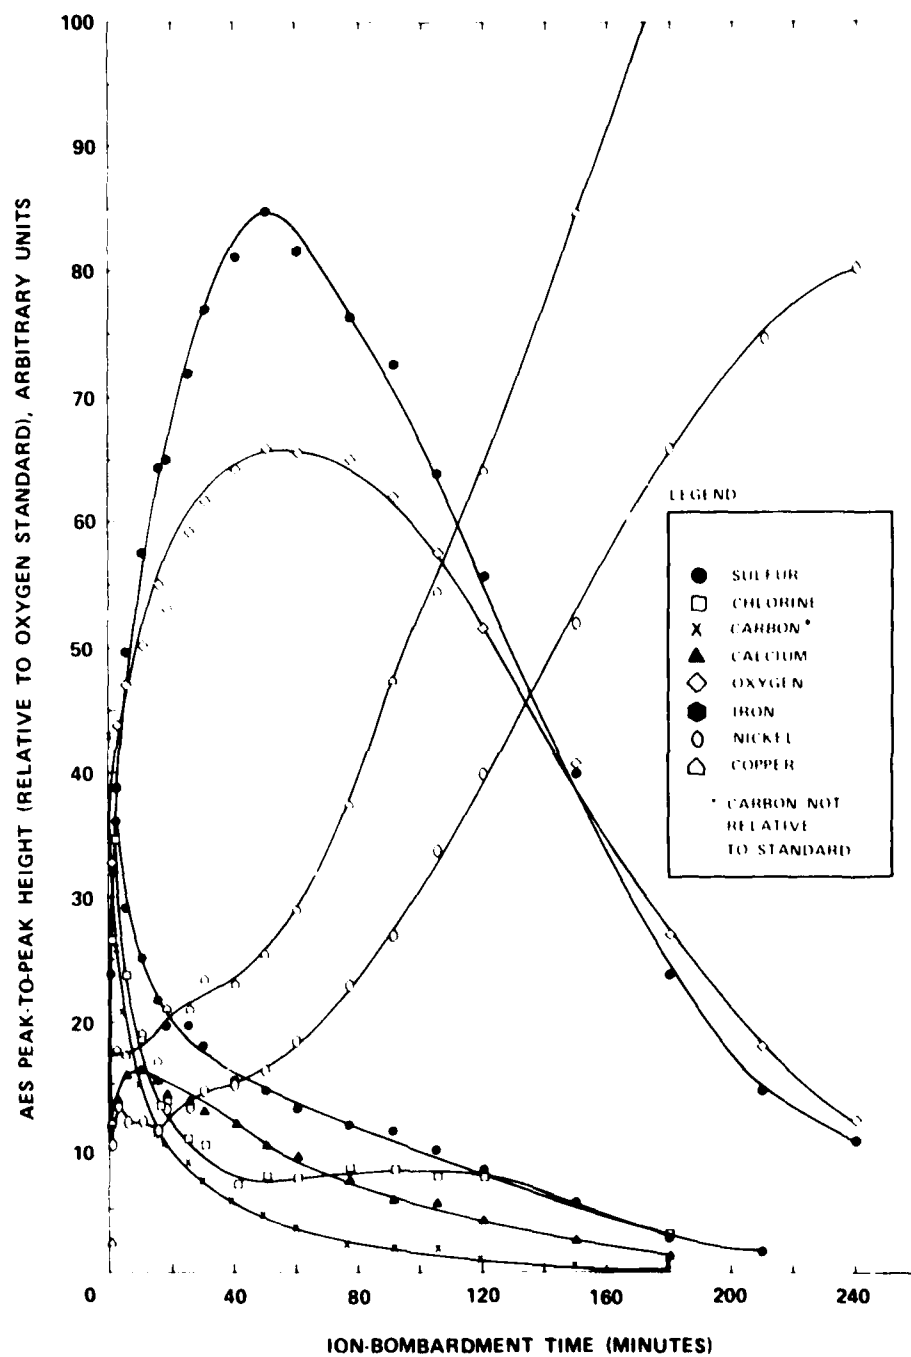
Figure 5 - Depth Profile of Elements in Bare Area of Surface
as Determined by Auger Electron Spectroscopic Analysis
During Ion-Bombardment: Copper-Nickel (Iron)
Alloy Exposed to Sulfide-Containing
Seawater for 60 Days

The AES analysis on the bare spots of a 60-day SSW sample yielded some features strikingly different than on corrosion films of the same sample. Iron peaked rapidly after commencement of ion-bombardment and was present in very large

amounts (up to three times as great as copper) for prolonged periods during ion-bombardment. From the beginning sulfur was present in large amounts and went through a high and relatively broad (compared to 30-day SSW) maximum. Chlorine was present in substantially smaller amounts than sulfur. Oxygen concentration was high along with the iron.

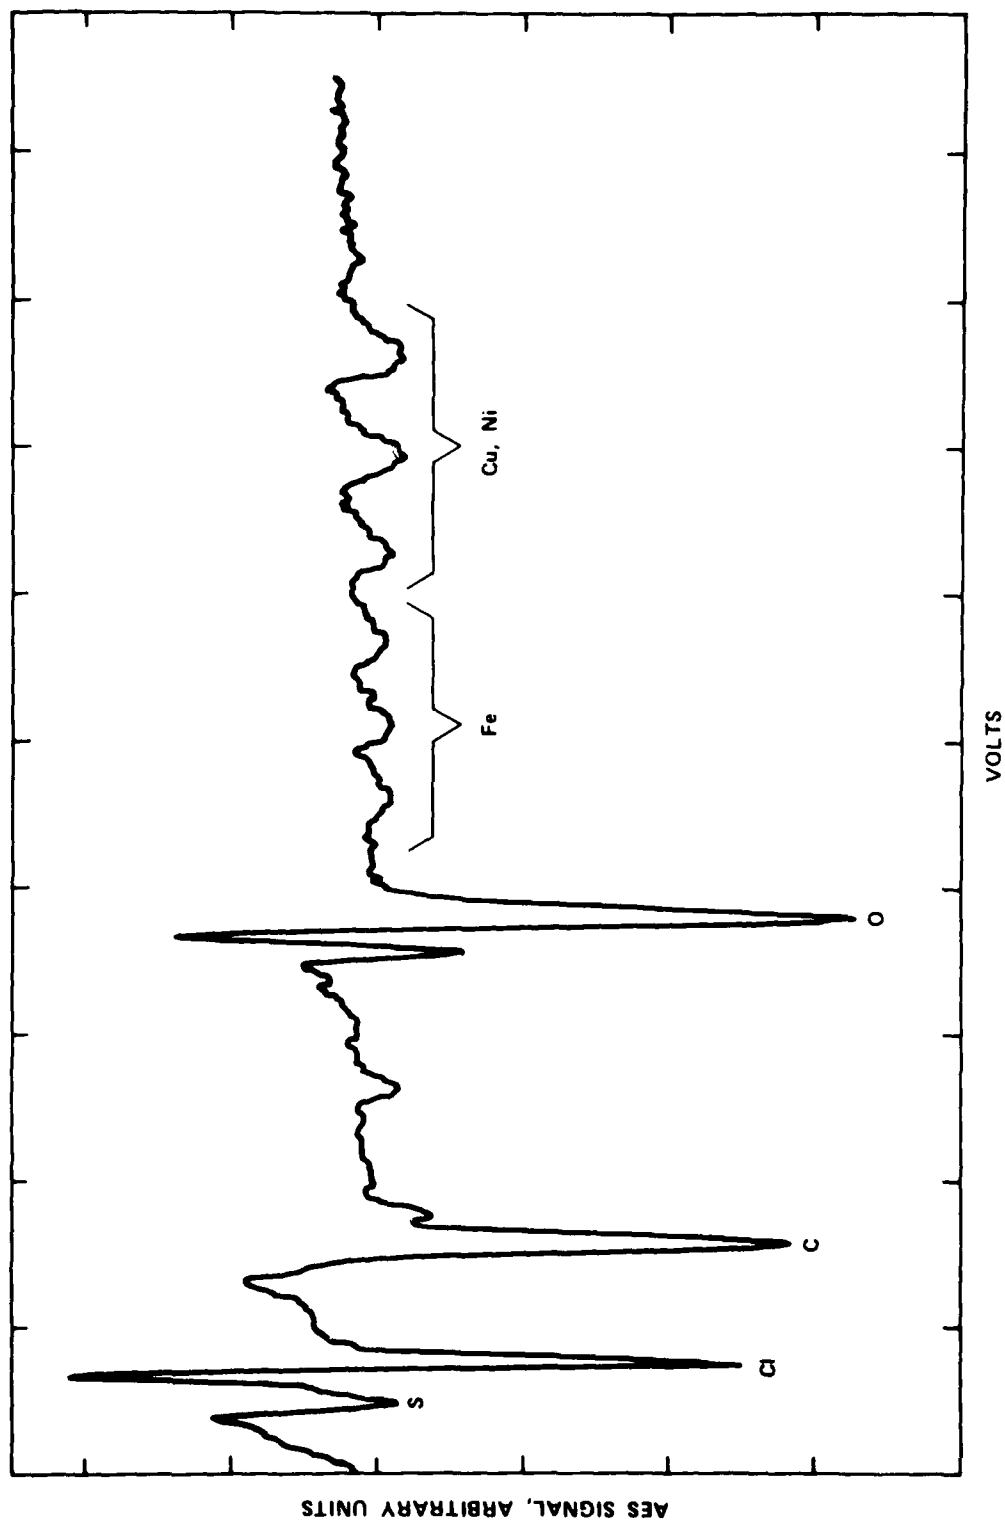
Figure 6 - Auger Electron Spectroscopic Analysis of Surface:
Copper-Nickel (Iron) Alloy Exposed to Fresh
Seawater for 90 Days

The AES analysis on 90-day exposed FSW samples at first yielded spectra with most peaks either undetectable or too small for useful measurement, due to the insulating characteristics of the thick corrosion film. Increase of the incident beam current from 10 μ A to 55 μ A, however, resulted in useful spectra with measurable peaks. The copper and nickel content (Figure 6) of these curves was greater than the iron content. The nickel curve was sometimes greater than copper, and in general, was higher relative to copper than to bulk composition. There was also evidence of silicon and magnesium, possibly in substantial amounts. AES analysis on 90-day exposed SSW samples once again yielded sharp differences between corrosion film (Figure 7) and bare spots (Figure 8). Now, however, the bare spot composition was low in iron and sulfur, high in copper and nickel, and enormously high in chlorine. The chlorine peaks were many fold greater than any others, and had to be measured at reduced sensitivity. The corrosion film, on the other hand, was relatively high in iron, oxygen, and sulfur, and greatly reduced in chlorine.
